Toxic and Hazardous  
Materials Agency

## Delivery Order 9 Enhanced Preliminary Assessment

**FORT DEVENS, MASSACHUSETTS**

April 1992

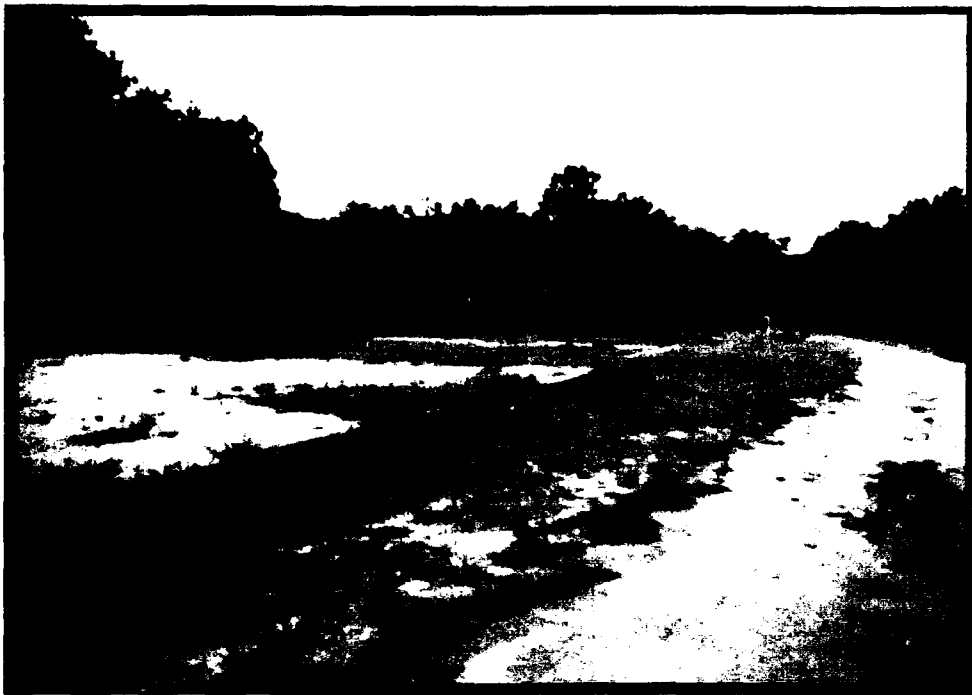
**11. AREE 20 - TYPICAL RAPID INFILTRATION BASIN**

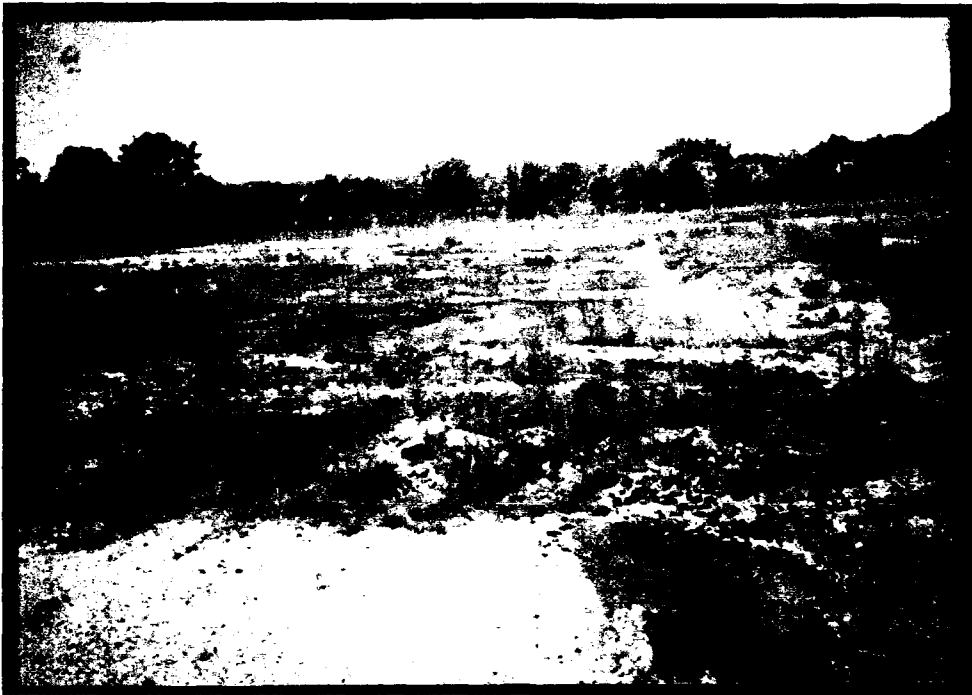
**17. AREE 26 - TYPICAL CONDITIONS AT ZULU II RANGE**

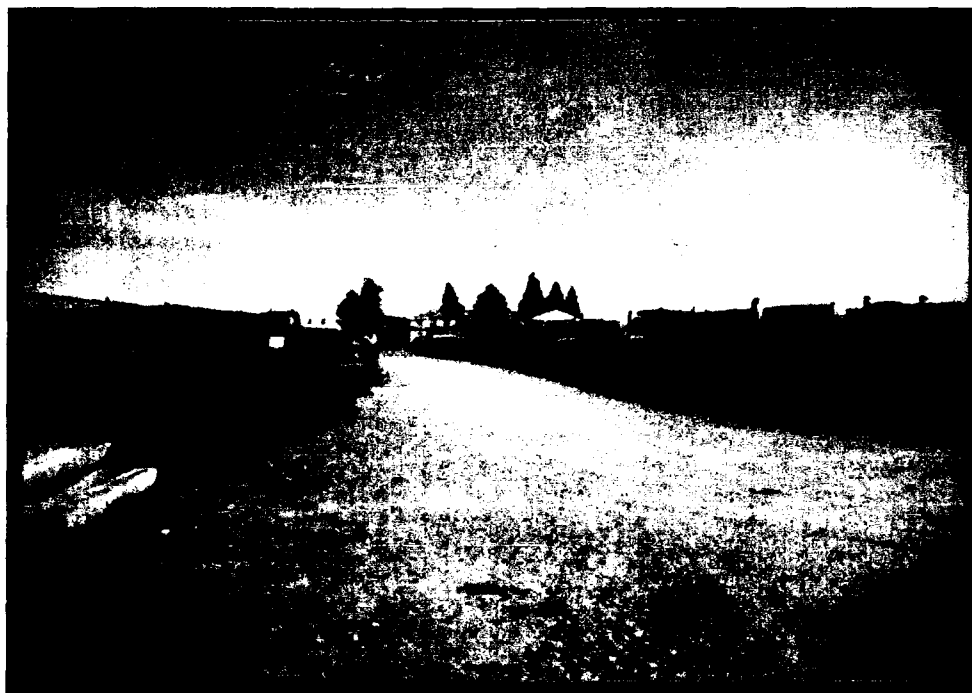
**20. AREE 50 - WWII ERA LUST SITE NEAR MAAF**
